CORROSION ANALYSIS OF METALLIC COMPONENTS IN ETECSA TELECOMMUNICATIONS INFRASTRUCTURE: ROLE OF COASTAL ATMOSPHERE IN CIEGO DE AVILA, CUBA

¹ Cuban Telecommunications Company (ETECSA) Ciego de Avila, Cuba.

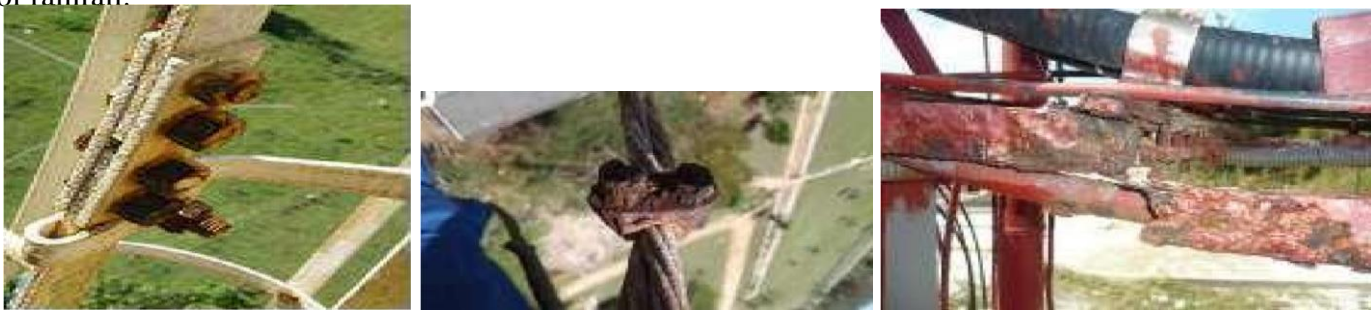
Figure (1): Effects of the coastal atmosphere on the corrosion of components in metal structures

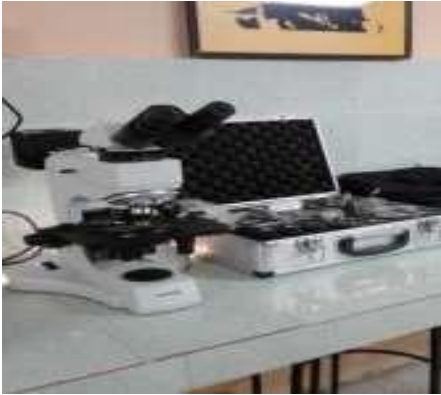
in coastal atmosphere at north of Ciego de Avila province. To observe the damage caused by corrosion, the samples were subjected to a metallographic analysis (micro level) in a NOVEL eye microscope (Figure 2) from which the corresponding images were obtained.

Figure (2): NOVEL brand metallographic microscope or electronic tweeter

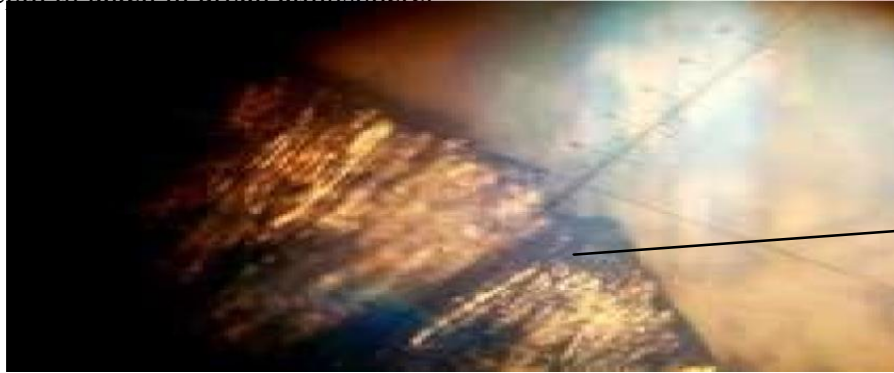
(a) Urban (b) Coastal

In Figure (3) it is shown the image corresponding to elements of a circular profile in the AT-60 structure, which reveals the loss in the metal of the paint layer and the appearance of pitting corrosion. Although the objective of this work was focused on the study of the phenomenon in a coastal atmosphere, it was considered important to present the comparison with another type to highlight the impact caused in the sample submitted to the marine environment. Denote of observation that the mark on the sample taken in coastal atmosphere

Pitting

was greater in size and depth to taken in urban atmosphere.

Figure (3): Cross section of circular profile elements in structures AT-60 model

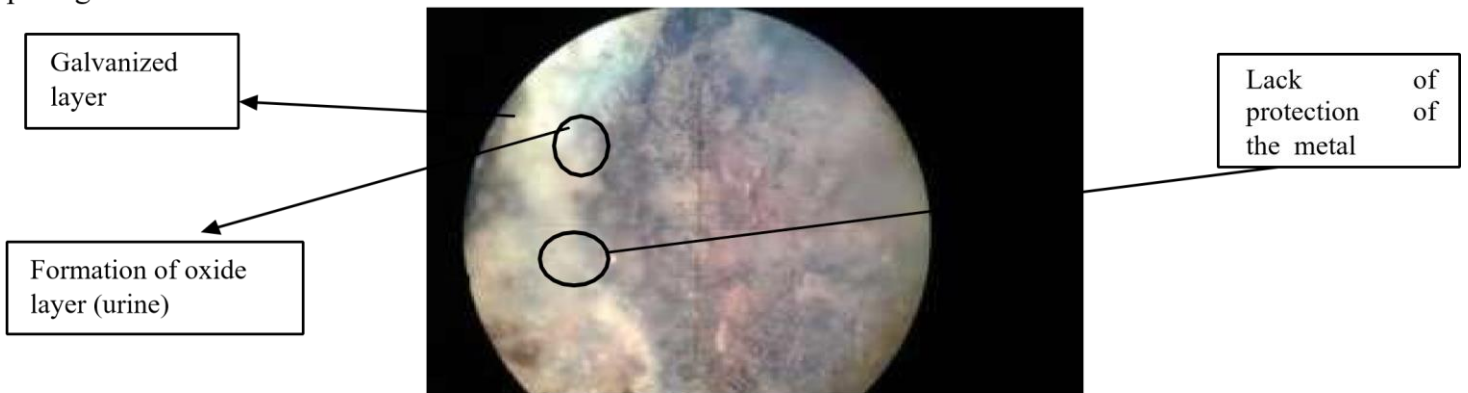
In the sample of Najasa model (Figure 4) the loss of the galvanized layer, the lack of protection of the metal with the consequent metallic luster and the onset of the formation of urine (oxide layer) detected by the reddish black color were observed. This phenomena shown on the iron surface is due to humidity or air.

Importantly that in both models was detected coexistence in loss of a portion of the plating layer with the start of pitting corrosion.

Figure (4): Surface of the part of an element of angular profile in structure of the Najasa model.

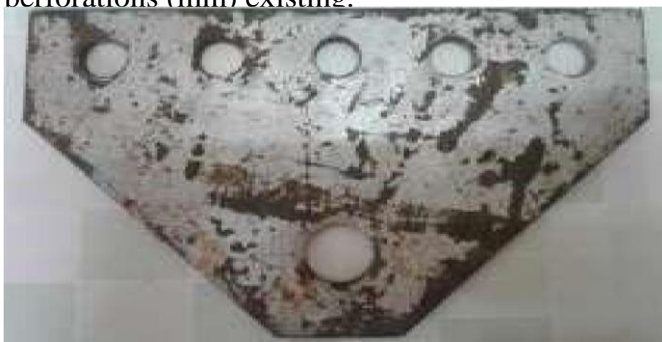
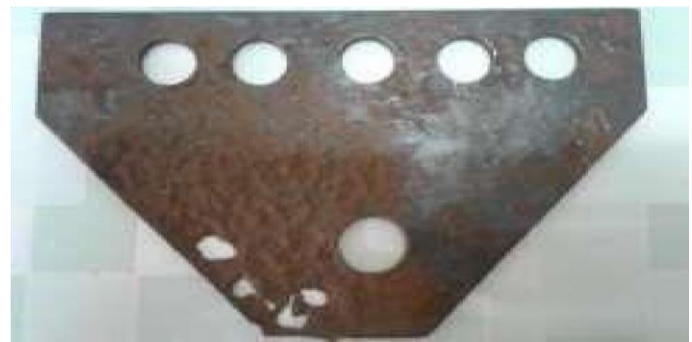
Figure (5): Structure equalizing plate AT-60

At the macro level, an equalizing plate supported on a model AT-60 structure was analyzed, applying the gravimetric analysis method to determine the loss of thickness (mm) and mass (g) and the diameter of the perforations (mm) existing.

(a) Corrosion-free part

(b) Corroded part

Initial thickness: 6 mm Final thickness varies from 0 to 3 mm depending on the affected section. When the final thickness was 3 mm, the loss corresponded to 50% When the final thickness was 2.5 mm, the loss corresponded to 58%.

When the final thickness was zero, the loss corresponded to 100%, therefore, it was complete.

The different perforations pitting existing, which are observed in Figure (5b), reached diameters of 9, 12.5, 13 and 17 mm

Initial mass: 1,395 g Final mass: 1,140 g.

Mass loss: 255 g which corresponded to 18.3 % of the initial mass.
