## Unveiling the Threat: Sea Level Rise and Saltwater Intrusion's Menace to Building Stability

**Keywords:** Sea Level Rise, Building Foundations, Global Mean Sea Level, Architectural Safety, Climate Change Impacts

### Abstract

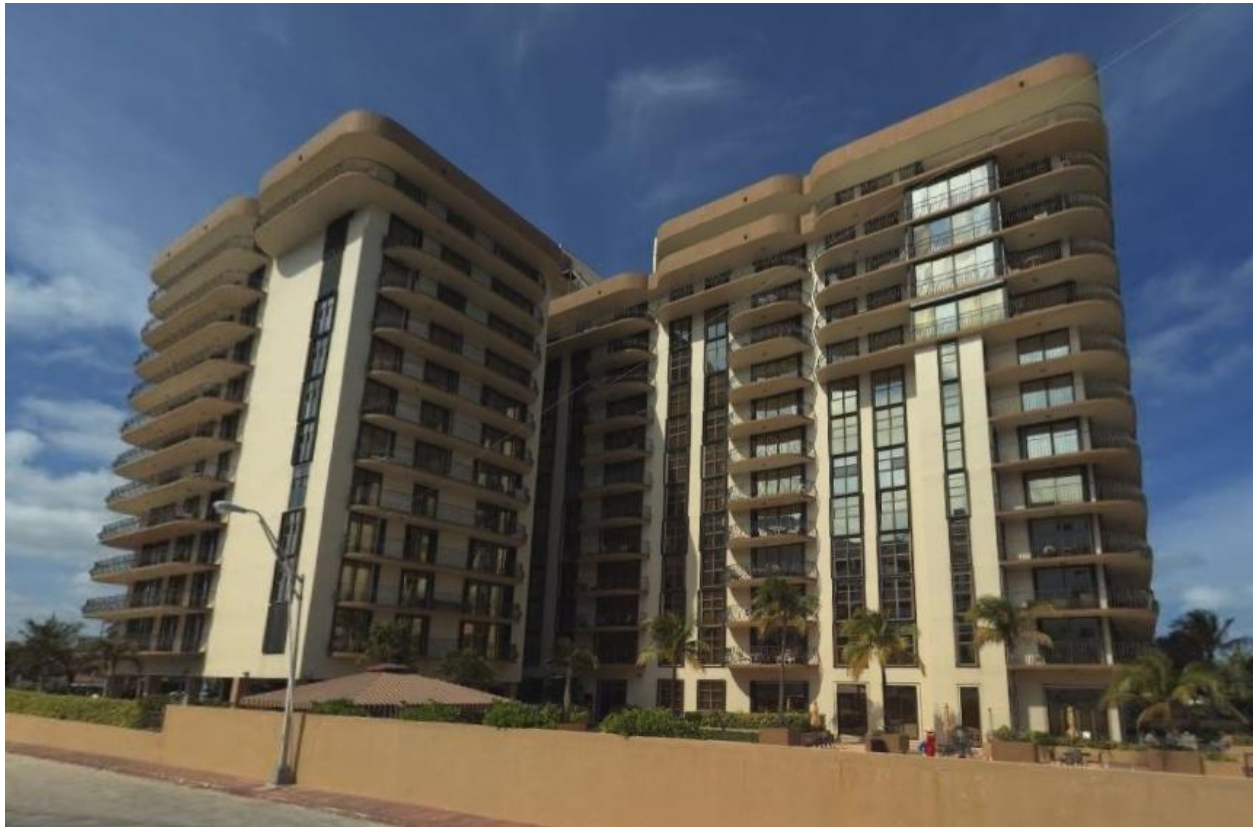
*Figure 1. Champlain Towers prior to the collapse of the south tower. The portion of building that collapsed is on the right.*

The failed condominium tower in Surfside (Figures 1 and 2), located in Miami-Dade County, had undertaken the required structural inspection. The engineer’s report, filed in 2018, identified structural issues in the basement of the building. The estimated cost to repair the structure was over \$15 million dollars, which amounted to an average assessment of \$120,000 per dwelling unit in a building where the average value of a unit was \$600,000 (Tolan 2021). In the three years following the last report on record, none of the repairs had been undertaken.
